Geotechnical Investigation - Proposed Residential Development, 5868 County Road 65, Port Hope, ON

November 18, 2022

Prepared for: Hillstreet Developments Ltd.

Cambium Reference: 15091-002

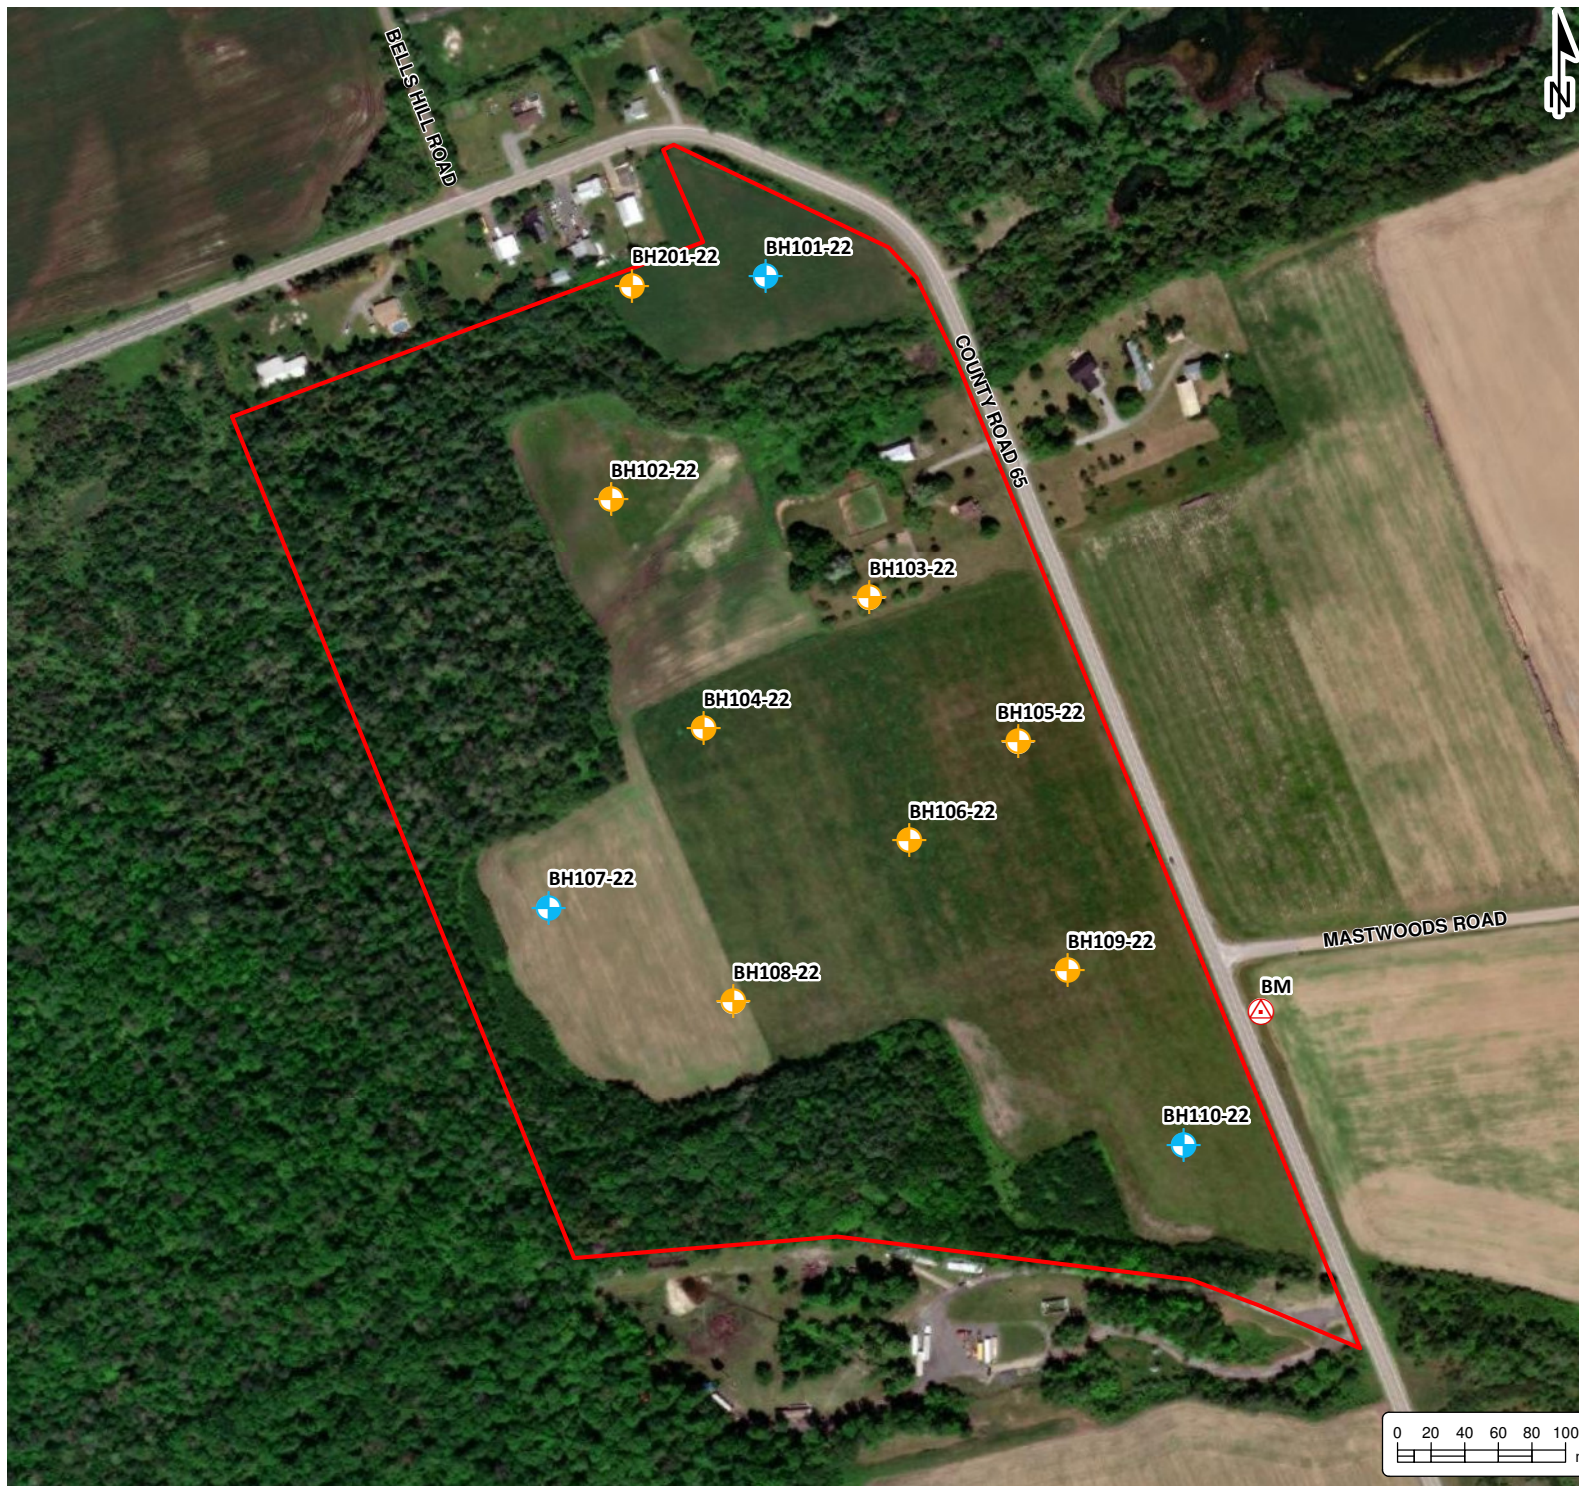
Project No.:	15091-002	Date:	October 2022
Scale:	1:4,500	Rev.:	
Created by:	DBB	Projection:	NAD 1983 UTM Zone 17N
Checked by:	BVj	Figure:	2

GEOTECHNICAL INVESTIGATION
HILLSTREET DEVELOPMENTS LTD.
5868 County Road 65,
Port Hope, Ontario

The field investigation involved advancing eleven (11) boreholes across the site from September 22nd to 23rd, 2022. Boreholes BH101-22 through BH110-22 were advanced to a depth of 6.7 mbgs. BH201-22 was advanced at the request of the Phase Two ESA to a depth of 1.5 mbgs. BH101-22 and BH201-22 were advanced in the northern portion of the property, north of the water feature. The remaining boreholes were advanced across the southern part of the property. The locations of the boreholes relative to the existing site conditions and proposed site conditions are provided on Figures 2 and 3, respectively. Records of the individual boreholes are provided on the Borehole Logs in Appendix A.

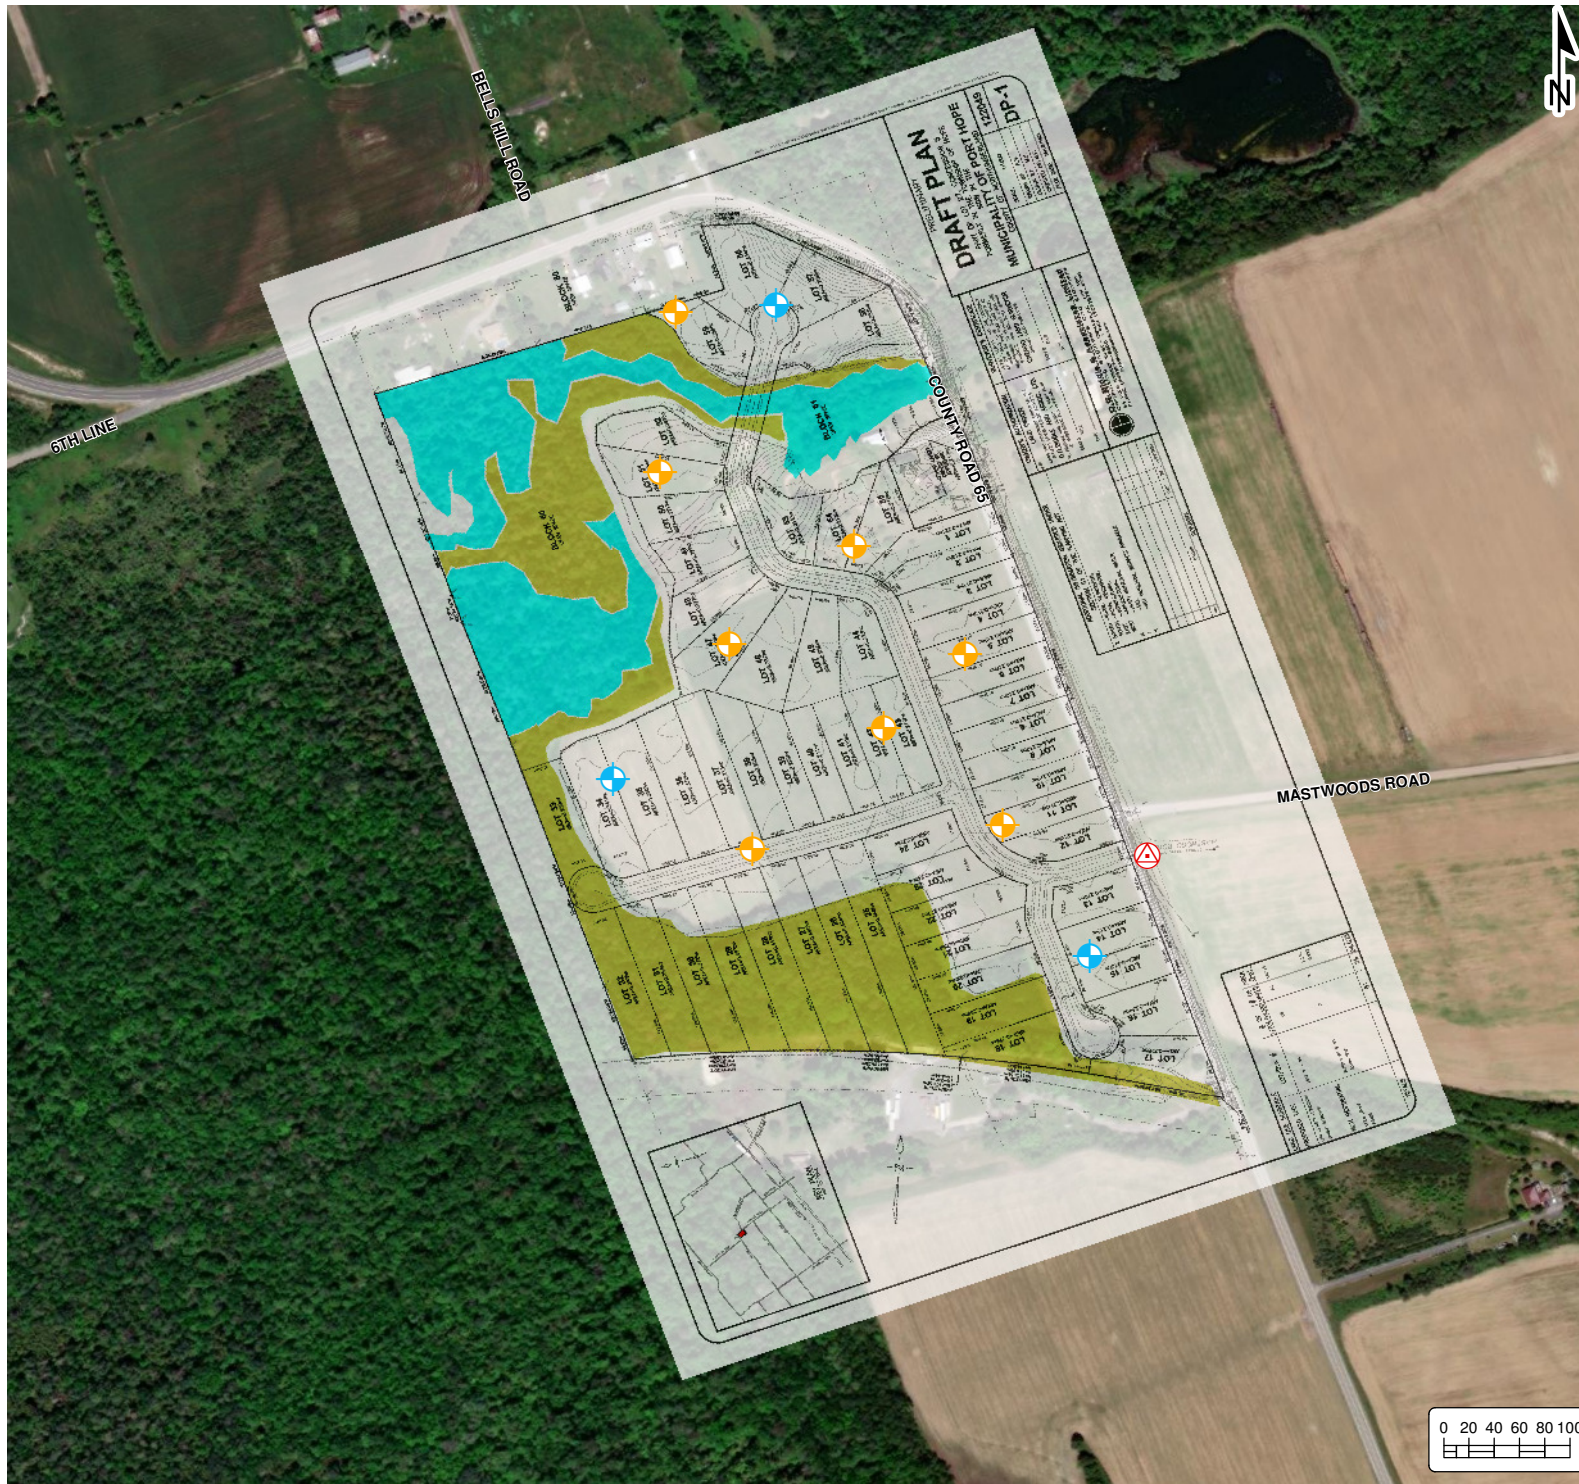
**BOREHOLE LOCATION PLAN-
 PROPOSED CONDITIONS**

GEOTECHNICAL INVESTIGATION
 HILLSTREET DEVELOPMENTS LTD.
 5868 County Road 65,
 Port Hope, Ontario

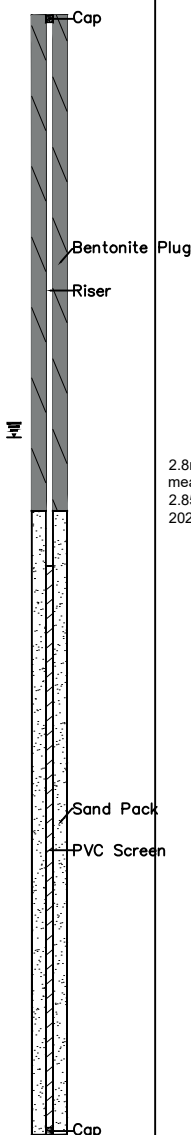
195.9	4													
195.4	4.5	(ML) sandy SILT: trace clay, compact, grey, wet	195.33	6	SS	40	27	17.3%				27		
194.9	5													
194.4	5.5

193.9	6													
193.4	6.5			7	SS	45	12	15.6%				12		
192.9	7	Borehole Terminated @ 6.7m Due to Targeted depth reached

2.8m: Groundwater measured at 2.85mbs in Oct, 2022

GRAINSIZE DISTRIBUTION	SAMPLE	GRAVEL	SAND	SILT	CLAY
	1.5	0	87	11	2

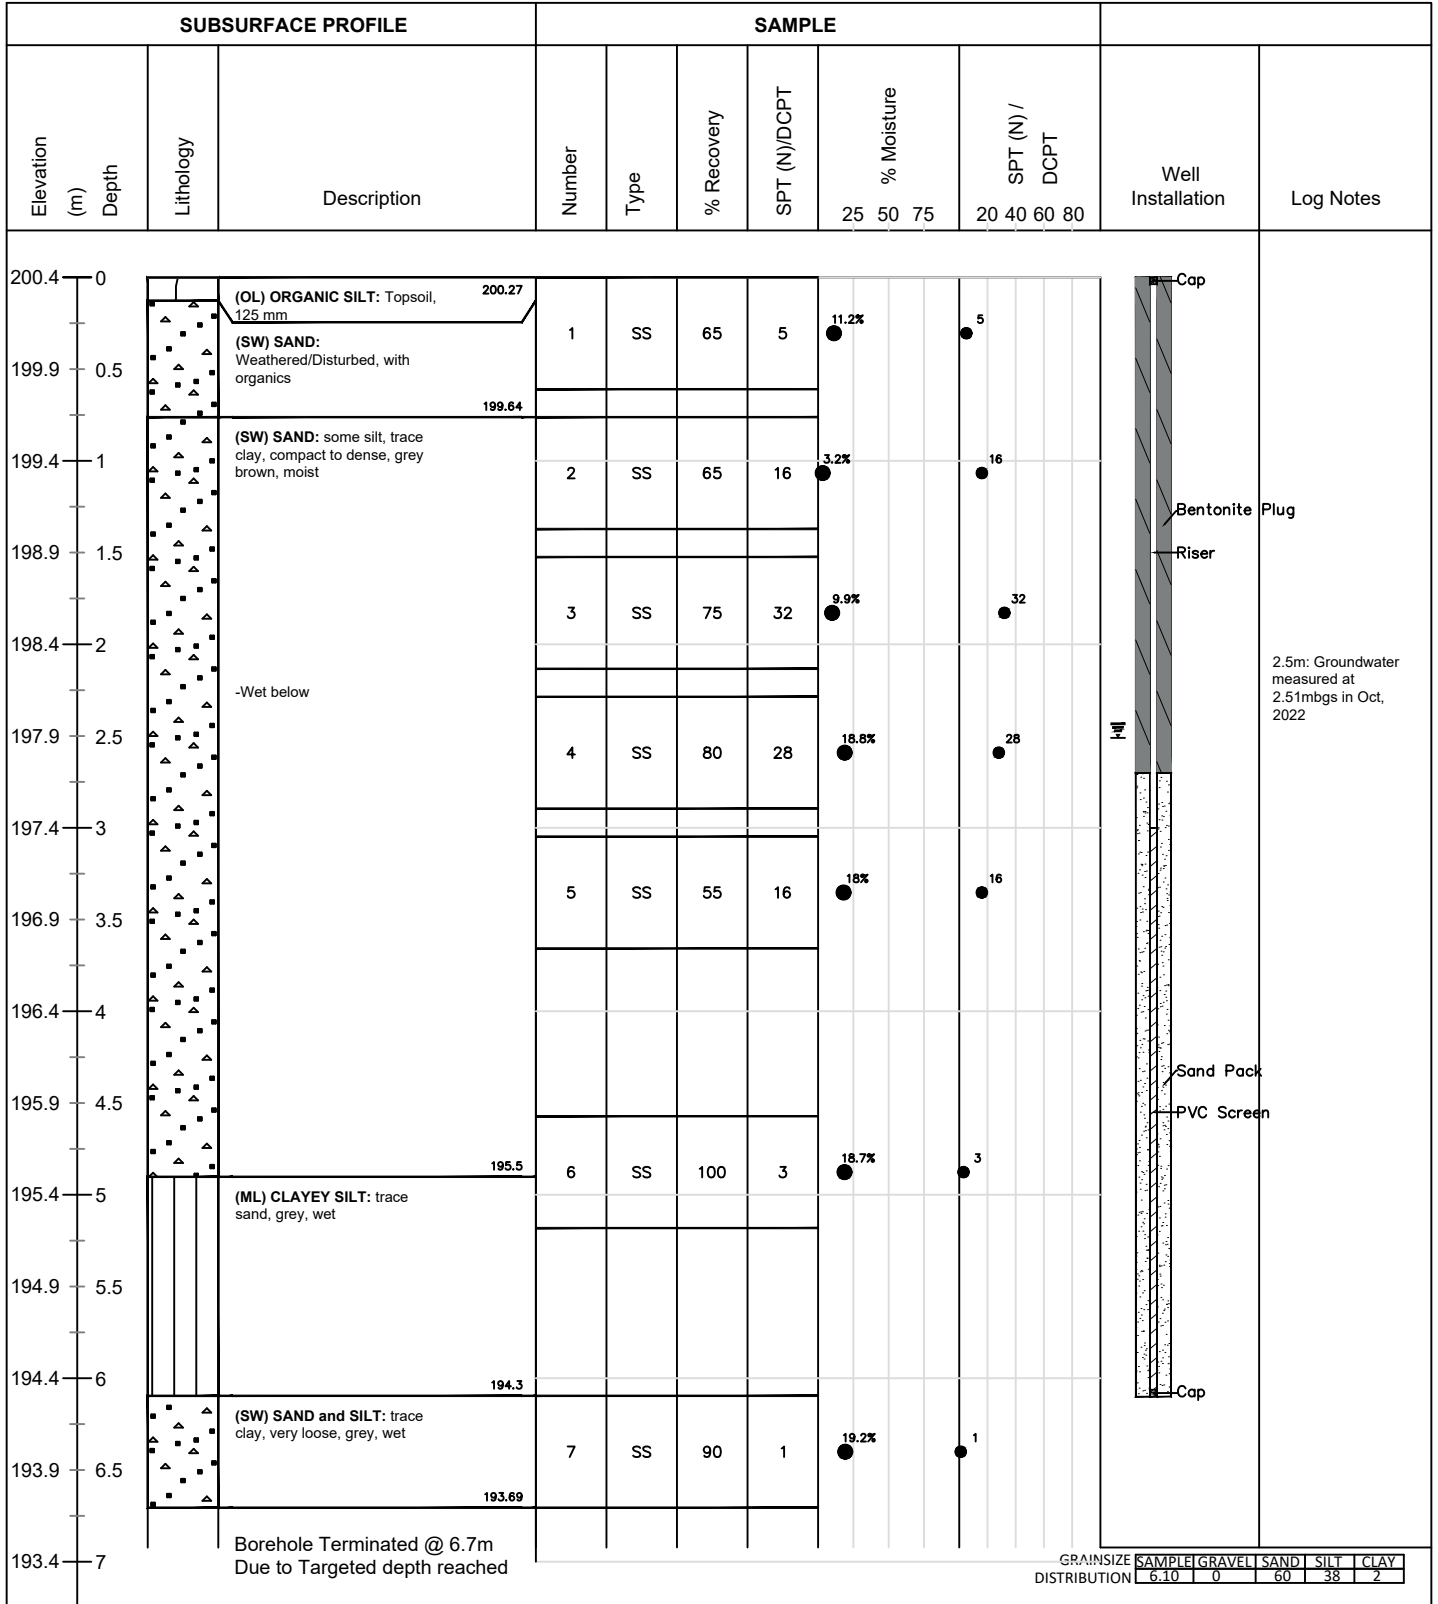
Log of Borehole: BH107-22
Page 1 of 1

Client: Hillstreet Developments LTD. Project Name: GEO - 5868 County Road 65, Port Hope ON Project No.: 15091-002
Contractor: CDN Method: Track Mounted Solid Stem Auger Date Completed: 09-22/23-2022
Location: 5868 County Road 65 UTM: 17 N: 4875603.9 E: 705359.7 Elevation: 200.4 m Rel.

GRAINSIZE DISTRIBUTION	SAMPLE	GRAVEL	SAND	SILT	CLAY
	6.10	0	60	38	2

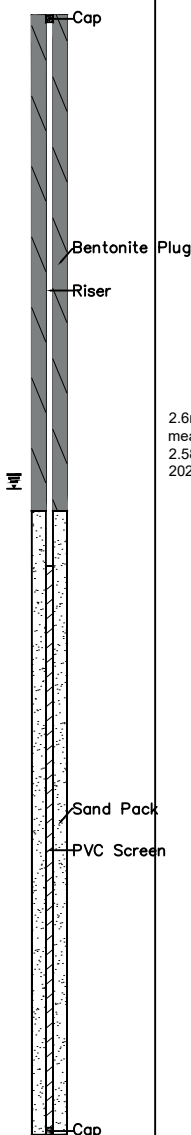
SUBSURFACE PROFILE				SAMPLE						Well Installation	Log Notes			
Elevation (m)	Depth	Lithology	Description	Number	Type	% Recovery	SPT (N)/DCPT	% Moisture				SPT (N) / DCPT		
								25	50	75	20	40	60	80
198.7	0	(OL) ORGANIC SILT: Topsoil, 150 mm	198.55	1	SS	95	5	7.1%				5		
198.2	0.5	(SW) SAND: Weathered/Disturbed, with organics	197.94											
197.7	1	(SW) SAND: some silt, trace clay, loose to compact, grey brown, moist -Wet below		2	SS	80	8	6.2%				8		
197.2	1.5													
196.7	2			3	SS	80	3	17.1%				3		
196.2	2.5													
195.7	3			4	SS	100	12	19.8%				12		
195.2	3.5													
194.7	4			5	SS	100	18	18.1%				18		
194.2	4.5													
193.7	5			6	SS	100	19	18.1%				19		
193.2	5.5													
192.7	6													
192.2	6.5			7	SS	100	22	16.1%				22		
191.7	7	Borehole Terminated @ 6.7m Due to Targeted depth reached

2.6m: Groundwater measured at 2.58mbs in Oct, 2022

GRAINSIZE DISTRIBUTION	SAMPLE	GRAVEL	SAND	SILT	CLAY
	2.30	0	82	16	2

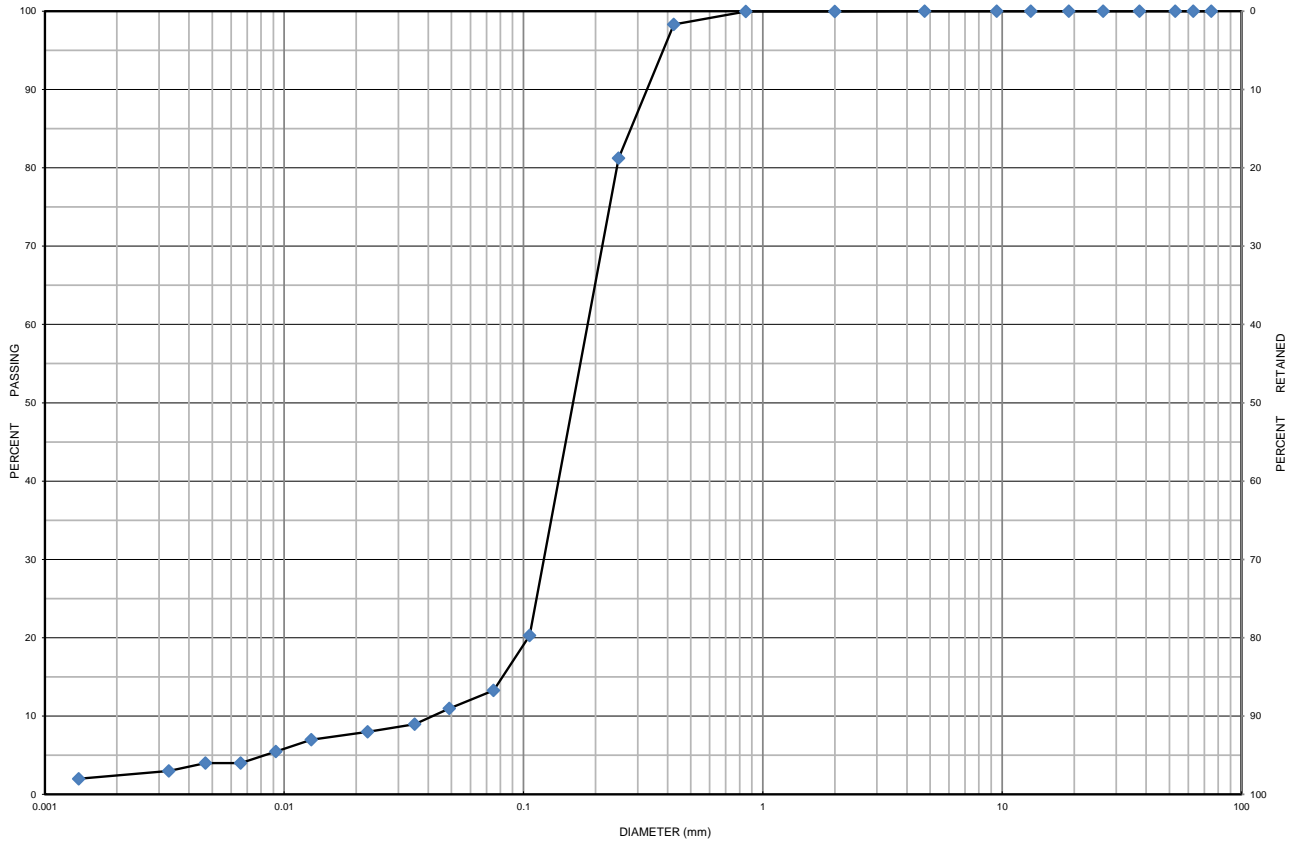
Project Number: 15091-002 **Client:** Hillstreet Developments Ltd
Project Name: GEO - 5868 County Road 65, Port Hope ON
Sample Date: September 23, 2022 **Sampled By:** Farhan Imtiaz - Cambium Inc.
Location: BH 101-22 SS 3 **Depth:** 1.5 m to 2.1 m **Lab Sample No:** S-22-1451

Borehole No.	Sample No.	Depth	Gravel	Sand	Silt	Clay	Moisture
BH 101-22	SS 3	1.5 m to 2.1 m	0	87	11	2	5.1
Description		Classification	D ₆₀	D ₃₀	D ₁₀	C _u	C _c
Sand some Silt trace Clay		SM	0.185	0.130	0.041	4.51	2.23

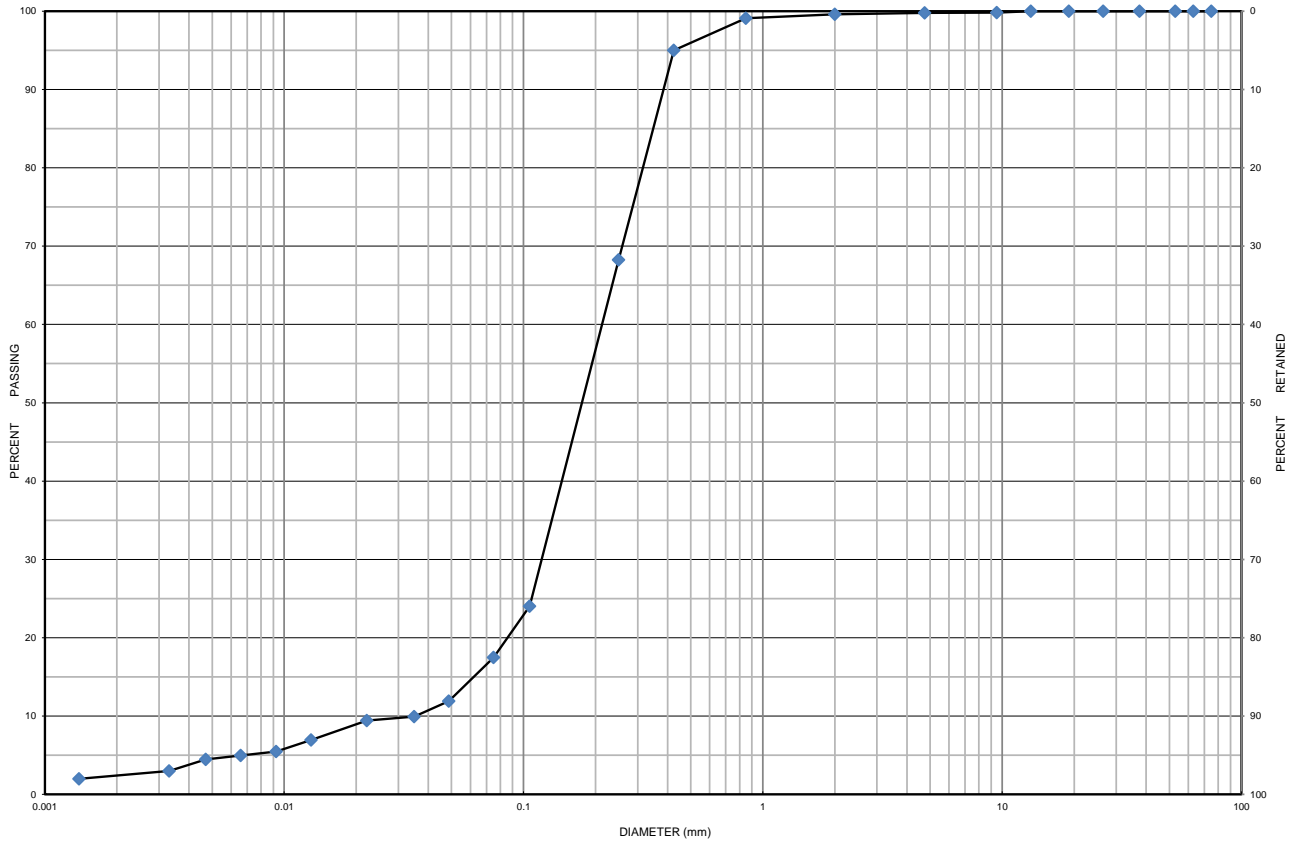
Project Number: 15091-002 **Client:** Hillstreet Developments Ltd
Project Name: GEO - 5868 County Road 65, Port Hope ON
Sample Date: September 23, 2022 **Sampled By:** Farhan Imtiaz - Cambium Inc.
Location: BH 110-22 SS 4 **Depth:** 2.3 m to 2.9 m **Lab Sample No:** S-22-1455

Borehole No.	Sample No.	Depth	Gravel	Sand	Silt	Clay	Moisture
BH 110-22	SS 4	2.3 m to 2.9 m	0	82	16	2	19.8
Description		Classification	D ₆₀	D ₃₀	D ₁₀	C _u	C _c
Sand some Silt trace Clay		SM	0.220	0.125	0.030	7.33	2.37

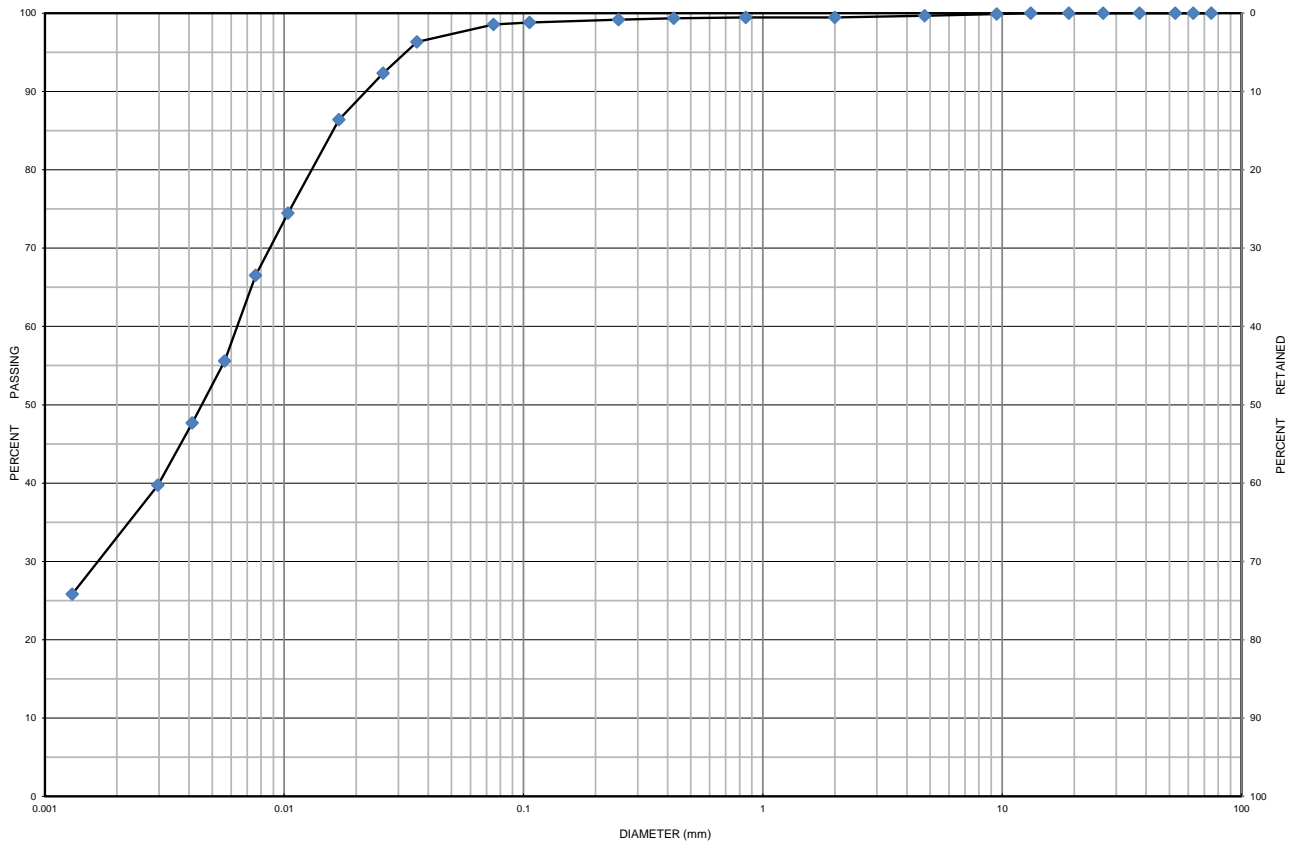
Project Number: 15091-002 **Client:** Hillstreet Developments Ltd
Project Name: GEO - 5868 County Road 65, Port Hope ON
Sample Date: September 23, 2022 **Sampled By:** Farhan Imtiaz - Cambium Inc.
Location: BH 102-22 SS 5 **Depth:** 3 m to 3.7 m **Lab Sample No:** S-22-1456

Borehole No.	Sample No.	Depth	Gravel	Sand	Silt	Clay	Moisture
BH 102-22	SS 5	3 m to 3.7 m	0	1	66	33	16.8
Description		Classification	D ₆₀	D ₃₀	D ₁₀	C _u	C _c
Clayey Silt trace Sand		ML	0.0064	0.0016	-	-	-

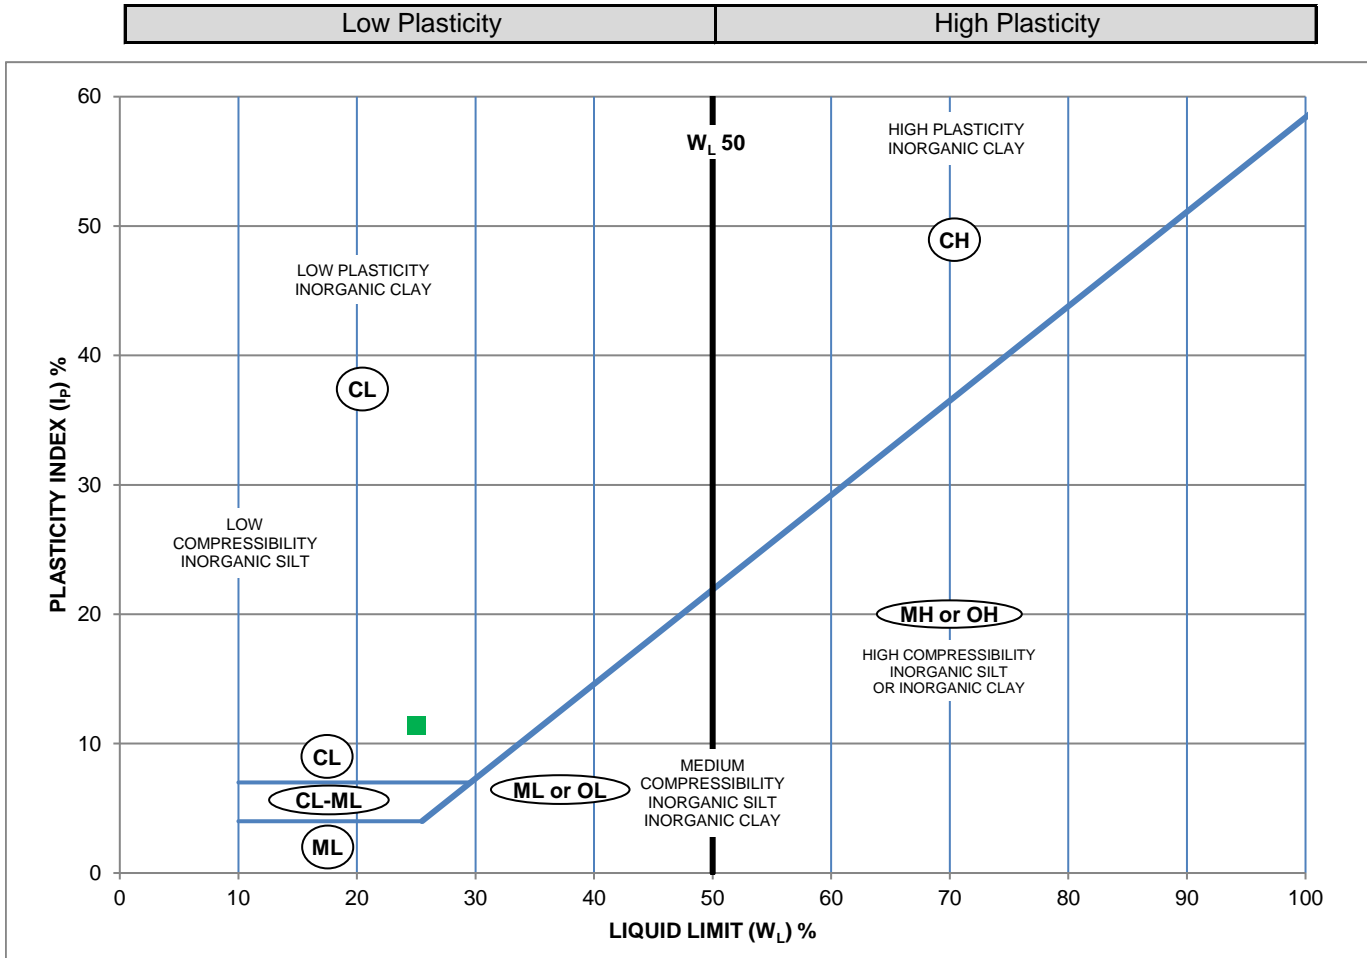
Hole No.: 102-22 SS 5 **Depth:** 3 m to 3.7 m **Lab Sample No:** S-22-1456

Symbol	Borehole	Sample	Depth	Description
■	102-22	SS 5	3 m to 3.7 m	Clayey Silt trace Sand

Liquid Limit (%)	Plastic Limit	Plasticity Index (%)
25.0	13.6	11.4

The results of the Atterberg limits testing indicate that the clayey silt deposit is of low plasticity in nature. Natural moisture contents of the clayey silt deposit range from 16.8 to 21.3 %.

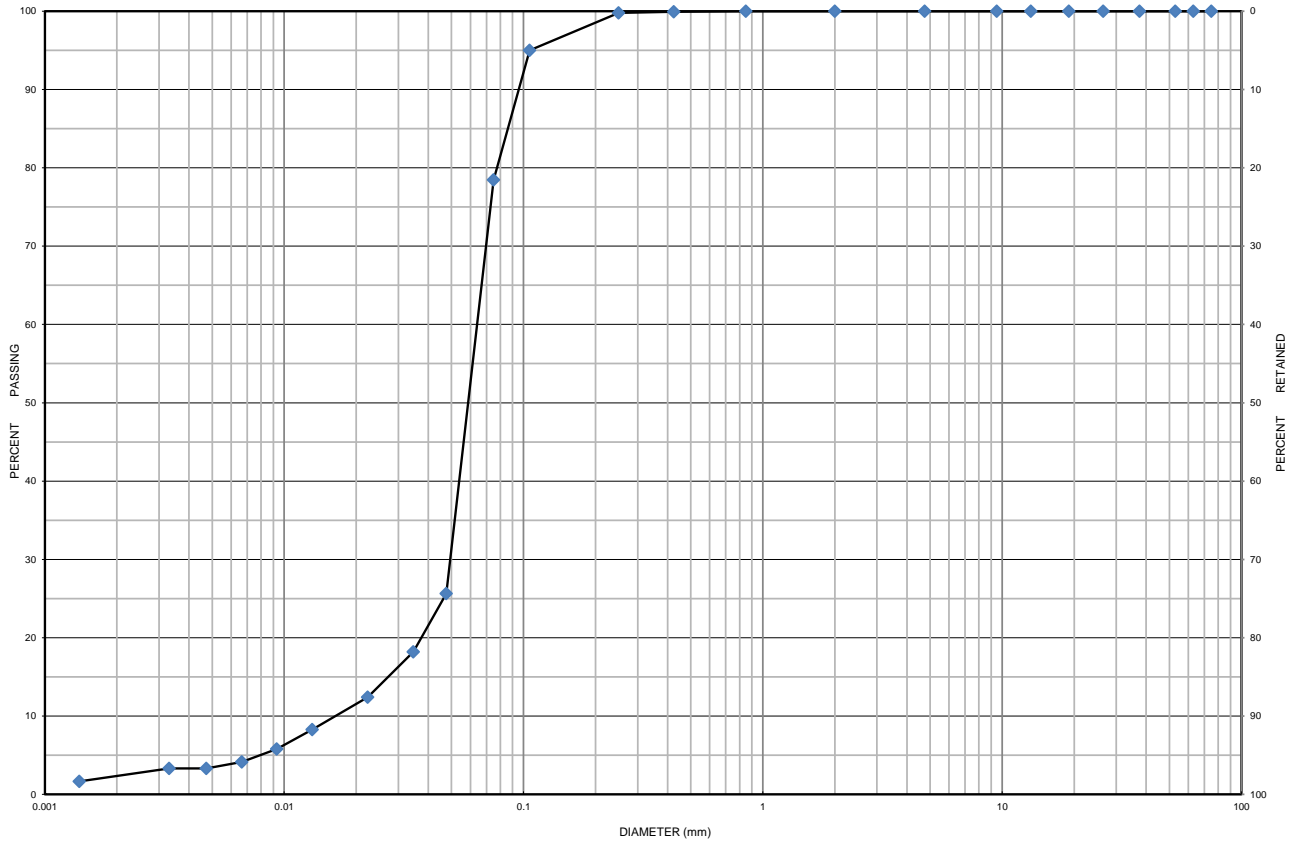
Project Number: 15091-002 **Client:** Hillstreet Developments Ltd
Project Name: GEO - 5868 County Road 65, Port Hope ON
Sample Date: September 23, 2022 **Sampled By:** Farhan Imtiaz - Cambium Inc.
Location: BH 102-22 SS 7 **Depth:** 6.1 m to 6.7 m **Lab Sample No:** S-22-1452

Borehole No.	Sample No.	Depth	Gravel	Sand	Silt	Clay	Moisture
BH 102-22	SS 7	6.1 m to 6.7 m	0	22	76	2	17.0
Description		Classification	D ₆₀	D ₃₀	D ₁₀	C _u	C _c
Sandy Silt trace Clay		ML	0.064	0.049	0.016	4.00	2.34

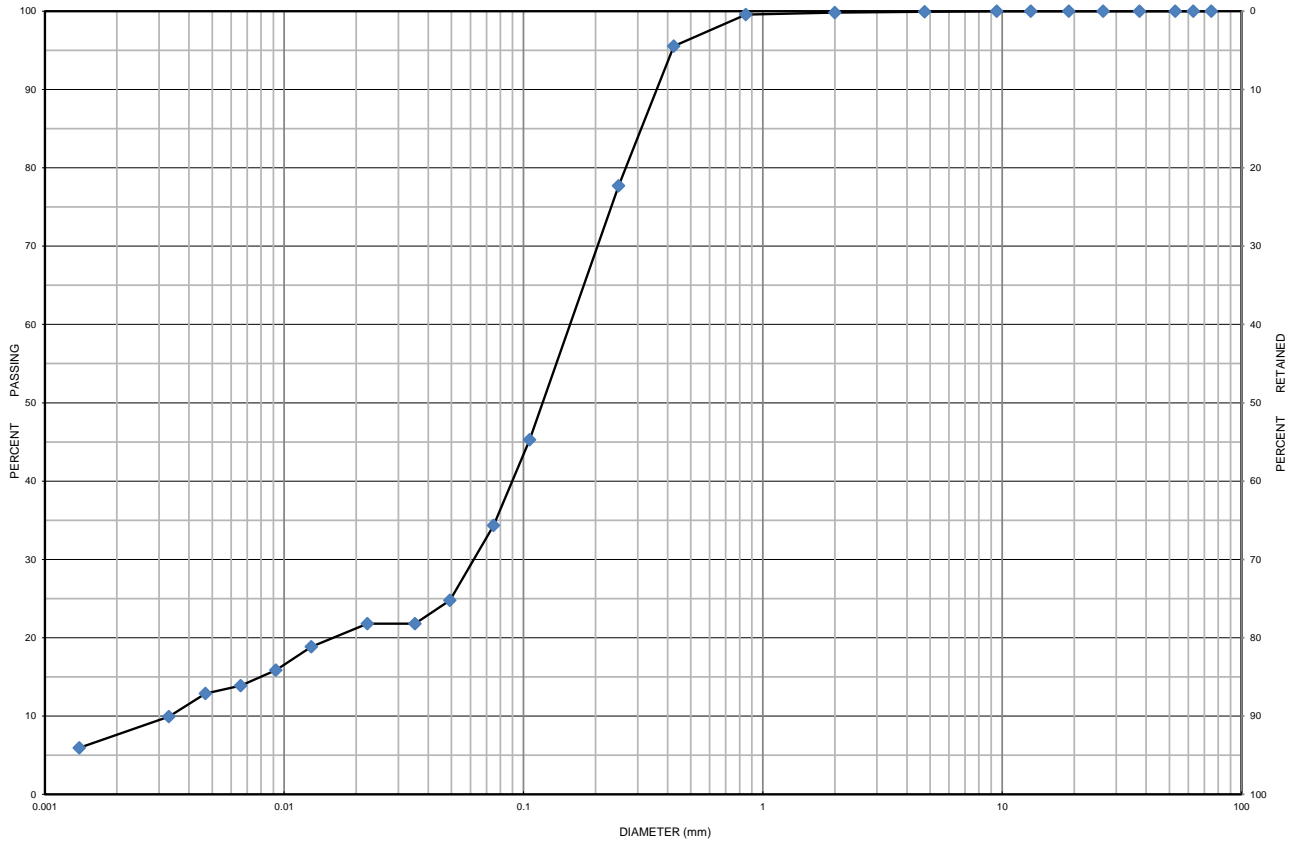
Project Number: 15091-002 **Client:** Hillstreet Developments Ltd
Project Name: GEO - 5868 County Road 65, Port Hope ON
Sample Date: September 23, 2022 **Sampled By:** Farhan Imtiaz - Cambium Inc.
Location: BH 105-22 SS 5 **Depth:** 3 m to 3.7 m **Lab Sample No:** S-22-1453

Borehole No.	Sample No.	Depth	Gravel	Sand	Silt	Clay	Moisture
BH 105-22	SS 5	3 m to 3.7 m	0	66	26	8	16.1
Description		Classification	D ₆₀	D ₃₀	D ₁₀	C _u	C _c
Silty Sand trace Clay		SM	0.1600	0.0610	0.0034	47.06	6.84

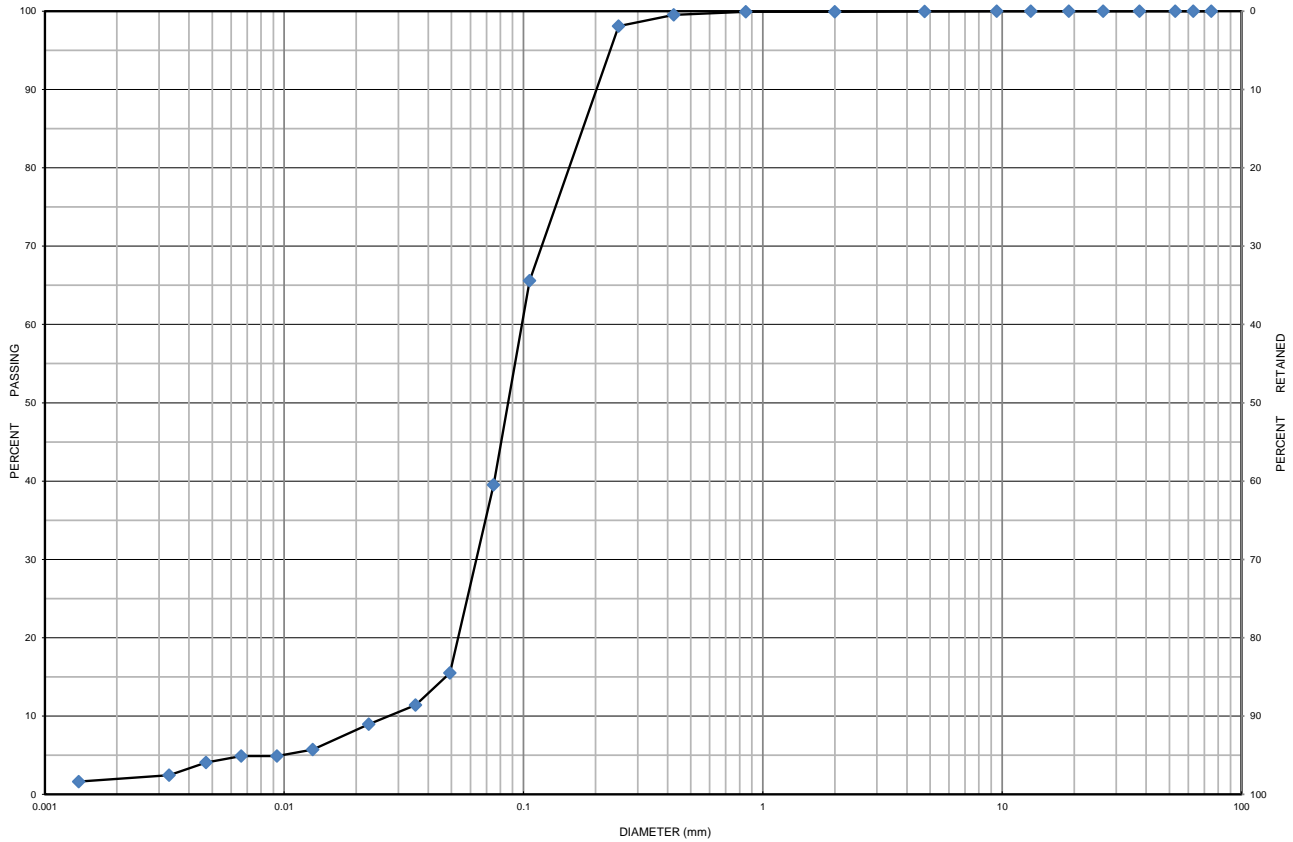
Project Number: 15091-002 **Client:** Hillstreet Developments Ltd
Project Name: GEO - 5868 County Road 65, Port Hope ON
Sample Date: September 23, 2022 **Sampled By:** Farhan Imtiaz - Cambium Inc.
Location: BH 107-22 SS 7 **Depth:** 6.1 m to 6.7 m **Lab Sample No:** S-22-1454

Borehole No.	Sample No.	Depth	Gravel	Sand	Silt	Clay	Moisture
BH 107-22	SS 7	6.1 m to 6.7 m	0	60	38	2	19.2
Description		Classification	D ₆₀	D ₃₀	D ₁₀	C _u	C _c
Sand and Silt trace Clay		SM	0.099	0.063	0.027	3.67	1.48
