**Phase Two  
Environmental Site  
Assessment - 5868  
County Road 65, Port  
Hope, Ontario**

October 21, 2022

Prepared for:  
Hillstreet Developments Ltd.

Cambium Reference: 15091-003

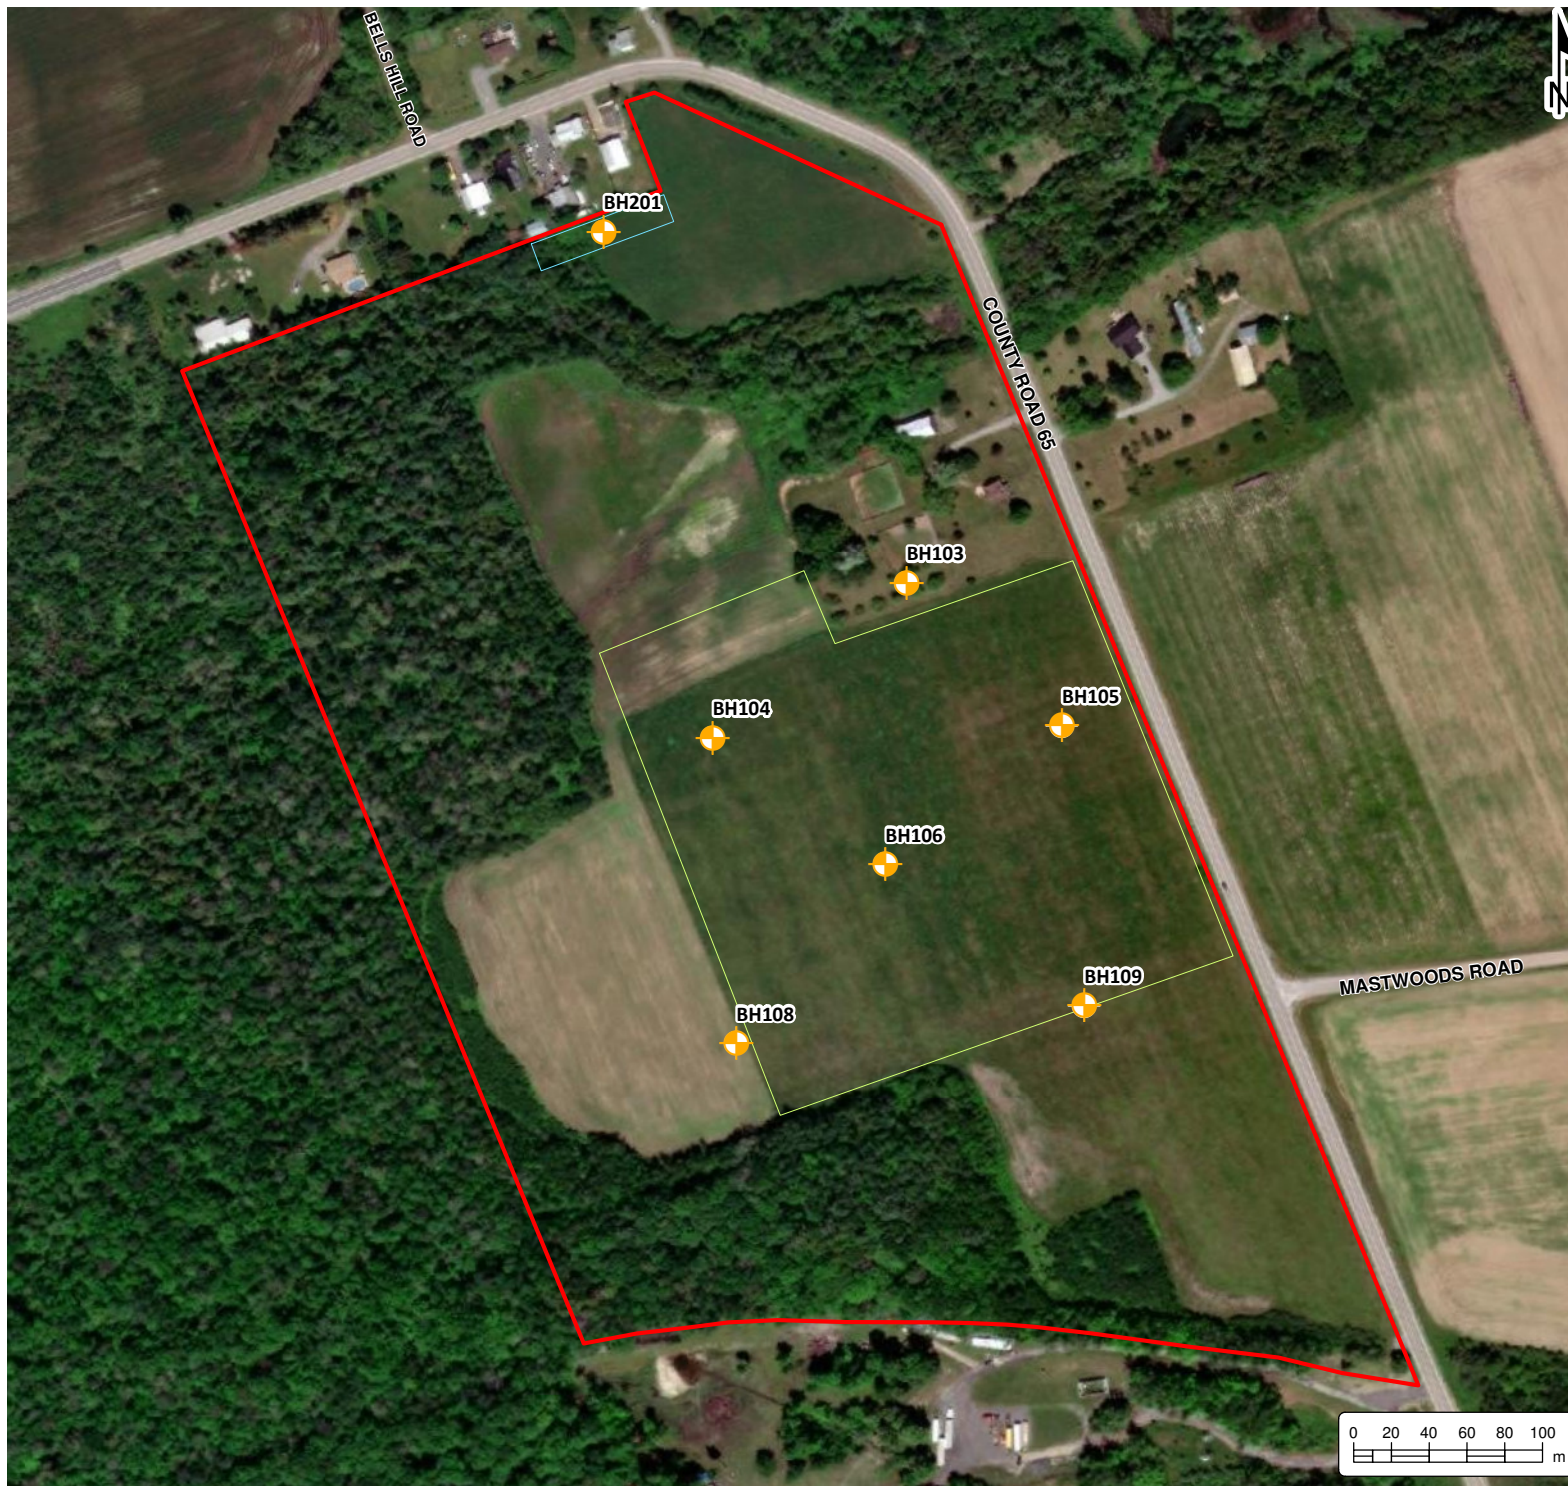
Project No.:	15091-003	Date:	October 2022
Scale:	1:4,000	Rev.:	
Created by:	DBB	Projection:	NAD 1983 UTM Zone 17N
Checked by:	AW	Figure:	<b>3</b>

The Phase Two Property location is shown on Figure 1. A Site plan of the Phase Two Property is shown in Figure 2.

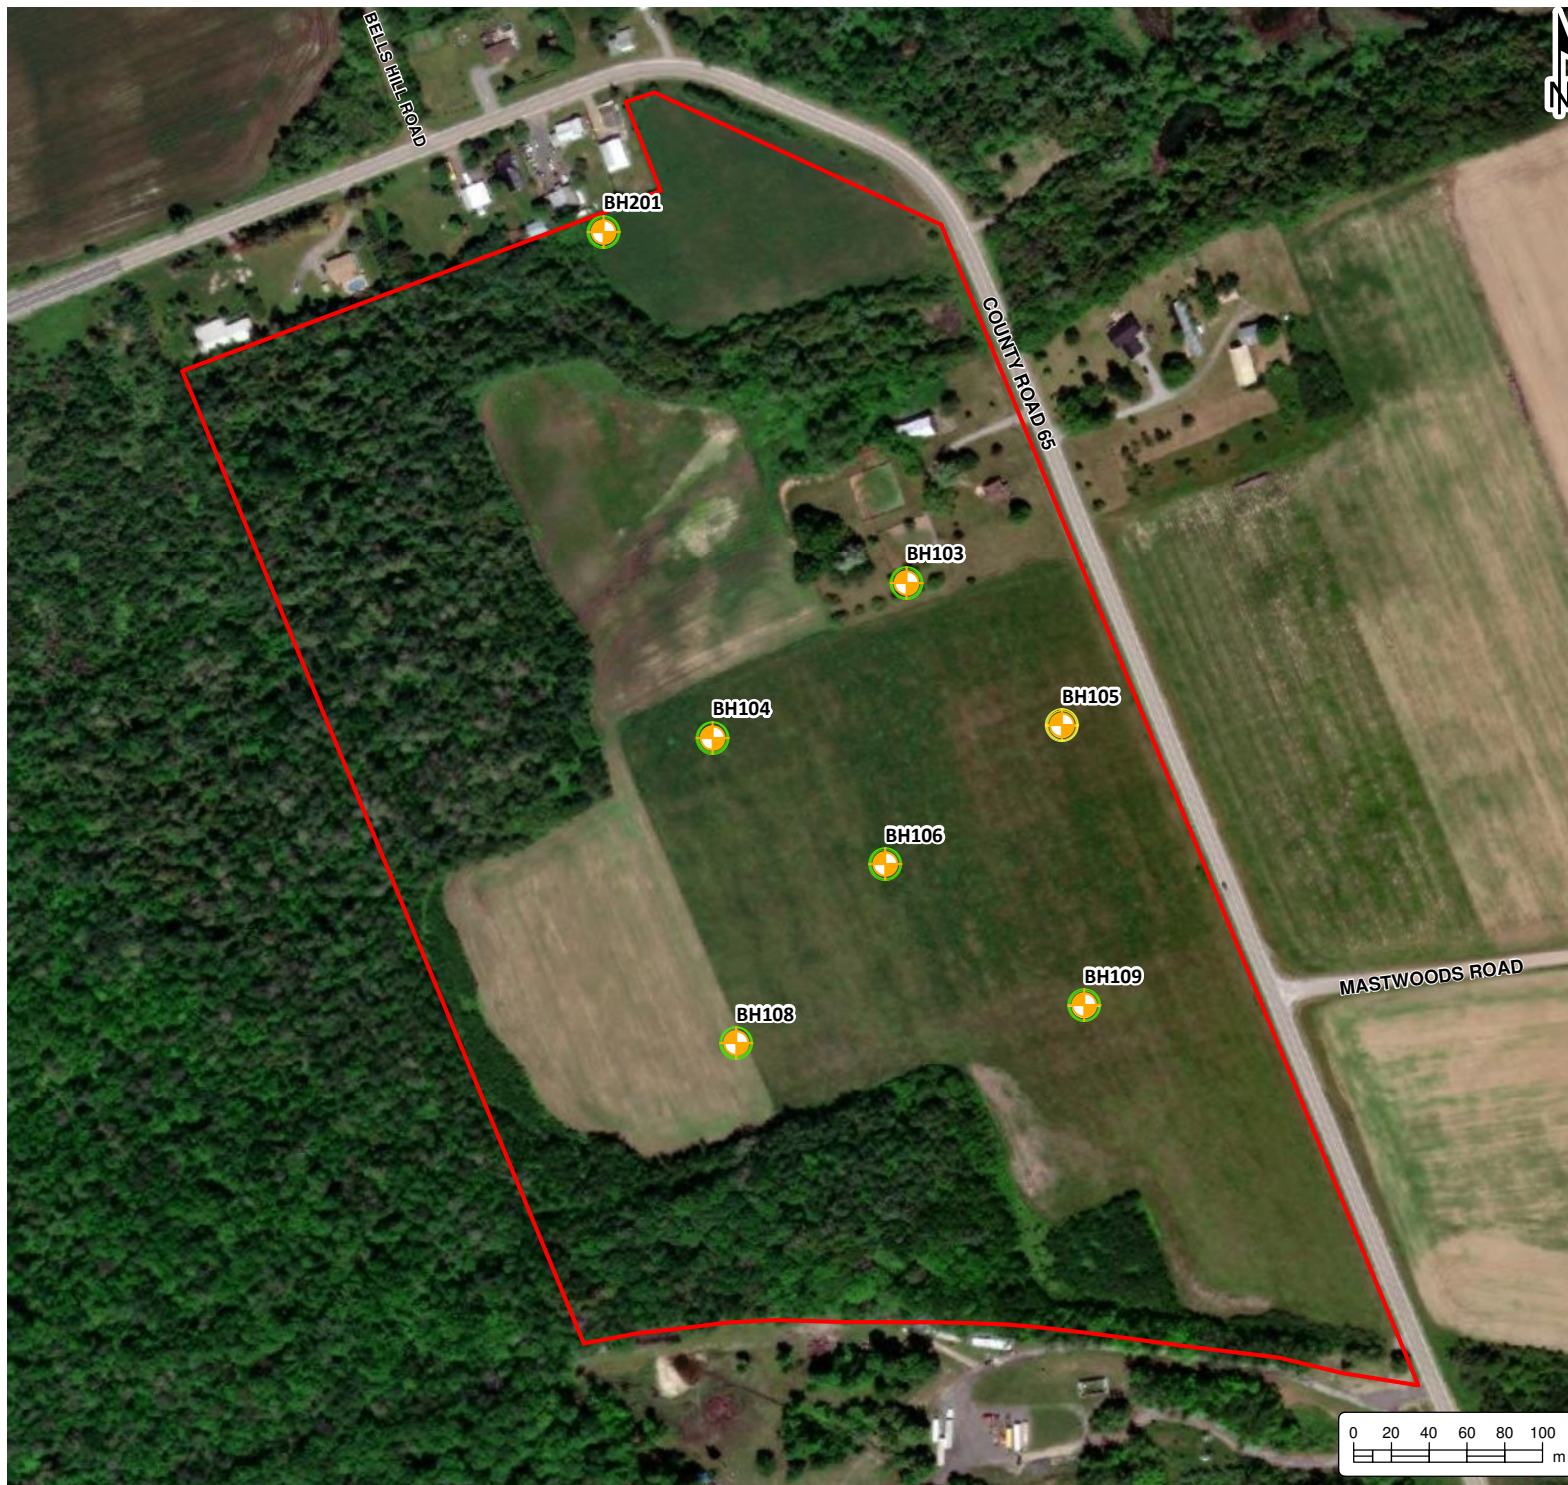
O:\GIS\MXDs\15000-15099\15091-1003 HillstreetDevelopment - Phase Two ESA - 5868 County Rd 65, Port Hope\2022-10-18 FIG 4\_Soil Results.mxd

The physiography and geology of the Site has been discussed previously in Section 3.1 and a detailed description of the subsurface soils can be found on the borehole logs provided in the geotechnical investigation report<sup>1</sup>. These logs present detailed descriptions of the soils and their associated characteristics to the maximum depth of investigation. Borehole and locations are shown on Figure 4.

Concentrations generally met the Table 8 SCS in the analysed soil samples, with the exception of Dichlorodiphenyldichloroethylene (DDE) which was noted at a concentration of 0.06 ug/g in BH105, marginally above the Table 8 SCS of 0.05 ug/g. It is noted that DDE was generally non-detect or met the Table 8 SCS in all other locations tested, and on average the Site would meet the standard. Based on the marginal exceedance, if Table 8 was required to be applied to the Site, the DDE exceedance would be isolated and simple to remediate during the Site development process.

Concentrations of all COPCs were found to meet the Table 2 SCS in the analyzed soil samples. The concentrations were also found to generally meet the Table 8 SCS, with the exception of a single marginal (0.01 ug/g) exceedance of DDE in BH105, which if Table 8 standard was applied to the Site, could be easily remediated based on its low concentration and isolation.

Concentrations generally met the Table 8 SCS in the analysed soil samples, with the exception of Dichlorodiphenyldichloroethylene (DDE) which was noted at a concentration of 0.06 ug/g in BH105, marginally above the Table 8 SCS of 0.05 ug/g. It is noted that DDE was generally non-detect or met the Table 8 SCS in all other locations tested, and on average the Site would meet the standard. Based on the marginal exceedance, if Table 8 was required to be applied to the Site, the DDE contaminated soil would be limited and could be remediated during the Site development process after which confirmation samples would be collected to confirm the impacts were removed.
