**Re: Update and Review of Phase 1 ESA's In Support of
Mason Penryn Ph 4, 5 and 9, Municipality of Port Hope, Ontario**

Re: Environmental Assessment for the Redner Farm
Property in Port Hope, Ontario
Our File: 3050403.00

Environmental Site Assessment
Redner Lands
Port Hope, Ontario
For: AON Inc.

**ENVIRONMENTAL SITE ASSESSMENT
PENRYN PROPERTY
PORT HOPE, ONTARIO**

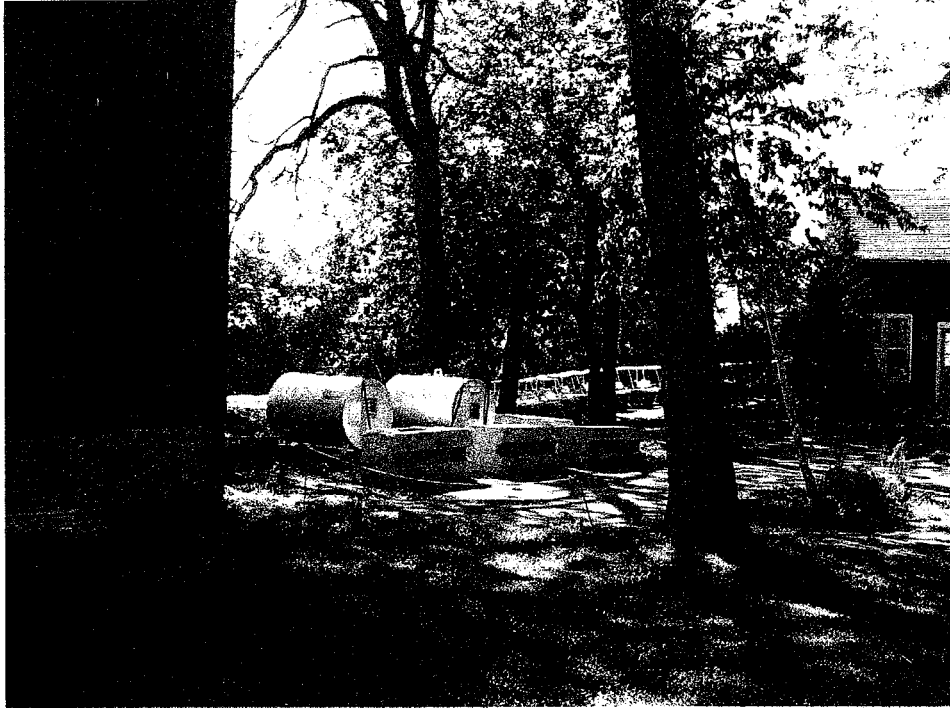
- Two relatively new above-ground fuel tanks, one gasoline and one diesel, are located in a gravel-surfaced area near the maintenance barn is shown on appended Photograph No. 1. There was no evidence of stains or odours near the tanks. Large concrete blocks next to the tanks prevent inadvertent damage from equipment and vehicles.

Photograph 1: Two fuel storage tanks located next to the Barn. The building in the right corner is the Red Barn which has been converted to a residence.

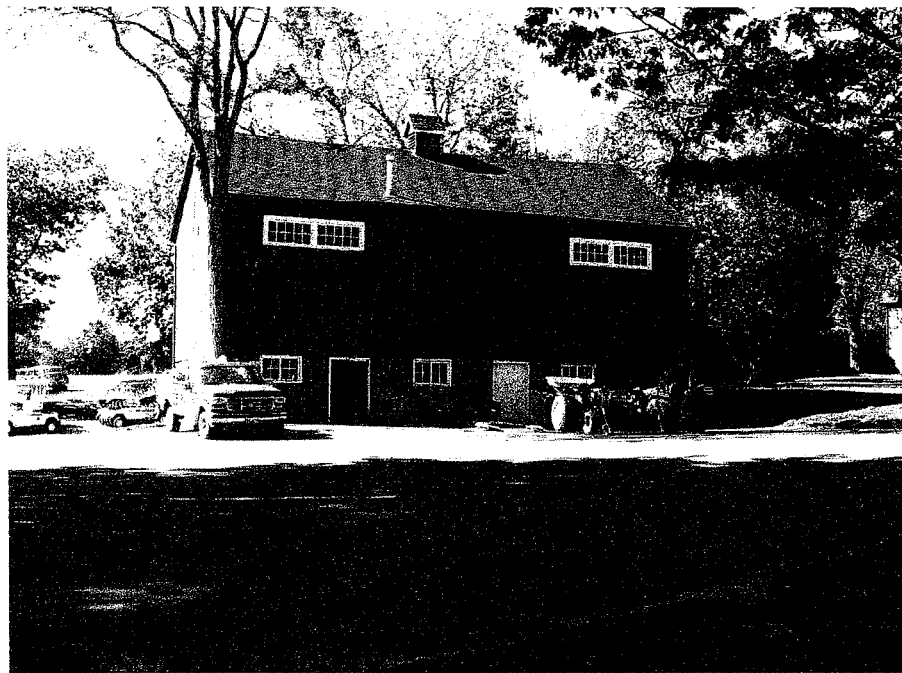
The clubhouse was clean and well maintained and no evidence of environmental concern was observed. The barn (see Appendix Photograph No. 4) also is relatively clean and well maintained and no evidence of significant staining was observed in the concrete floor or gravel surfaced areas adjacent to the barn.

- A small above-ground hydraulic lift exists in front of the maintenance barn. We did not see any evidence of spills or stains near the lift, which is visible next to the tractor on the appended Photograph No. 4.

Photograph 4: Looking northerly at the works barn. Above ground hydraulic hoist is located beside the tractor.
